## **ANGELHY**

**Innovative solutions for design and strengthening of  
telecommunications and transmission lattice towers using large angles  
from high strength steel and hybrid techniques of angles with FRP  
strips**

### **WORK PACKAGE 2 – DELIVERABLE 2.5**

**Report on full scale experimental tests for complete towers**

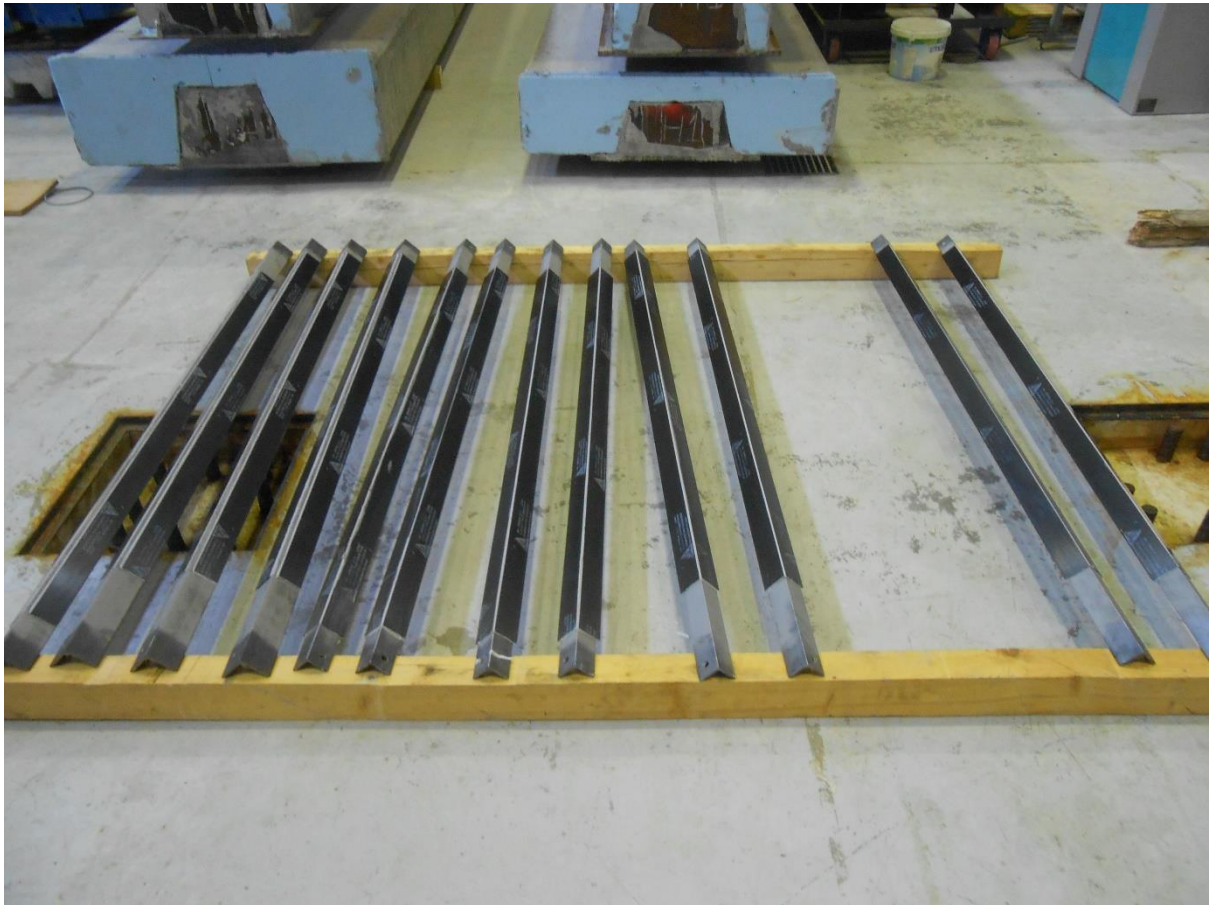
**Figure 2.4: Tower braces and legs strengthened by FRPs**

Strengthening of steel members by FRPs was performed at the Laboratory in NTUA. The steel profiles were sandblasted first. Subsequently FRPS strips were applied using exactly the same procedures as described in Deliverable 2.3. Members were strengthened over the full clear length between bolts. Fig. 2.4 shows pictures of strengthened members. For the strengthened angle sections

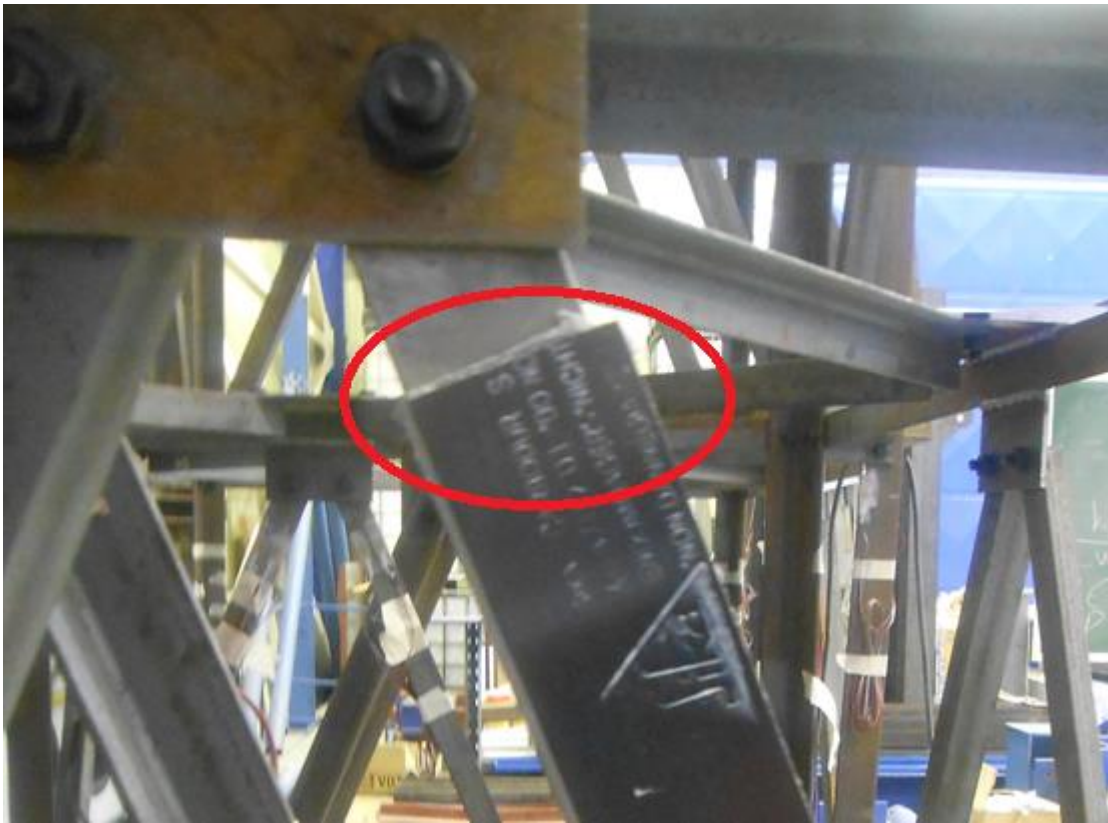
**Figure 2.5: Outstand for wider FRP than angle leg L45.45.5**

L45.45.5 in tower O1-S, the FRP strips were 5 mm wider than the angle leg and accordingly protruded over the angle tips, Fig. 2.5.

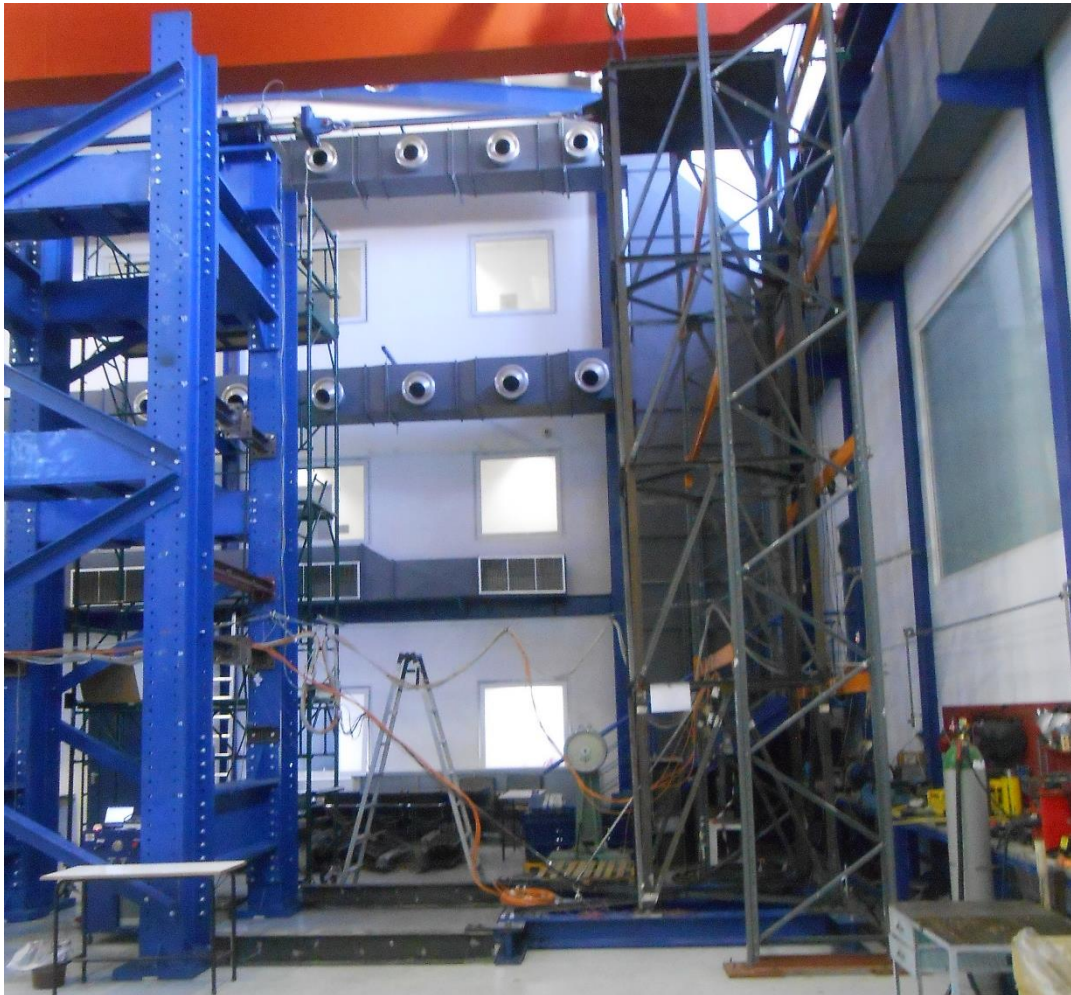
**Figure 4.1: Reaction frame (left) and tower specimen (right)**

The tests were performed on the strong floor area of the Laboratory. The towers were connected to a base structure which was anchored to the strong floor and were pulled at the top level by an actuator type MALVASIA with a capacity of 600 kN that rested on the top of a rigid reaction frame, Fig. 4.1.

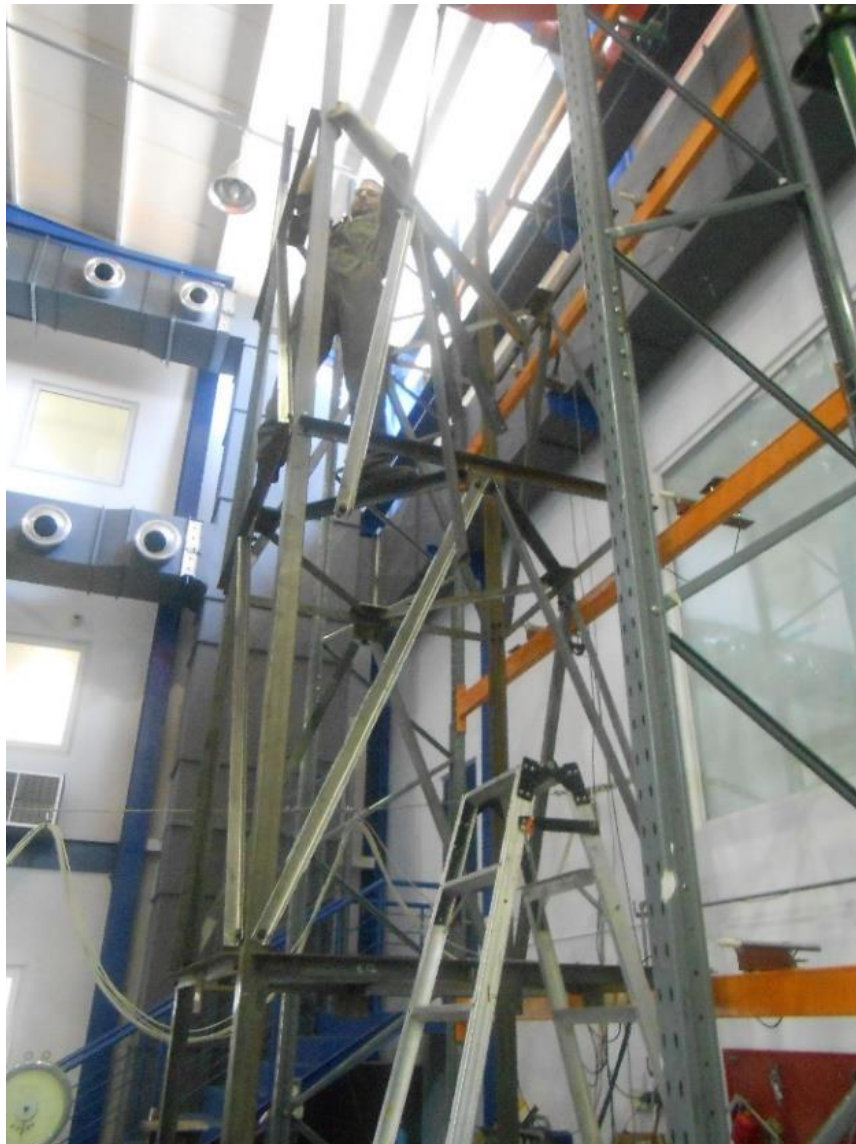
**Figure 4.4: Erection of the tower**

The erection was carried out by the personnel of the Laboratory from the bottom to the top. It started with the position of the four legs on the base structure. Then the horizontal bars of the first level were bolted to the legs in order to ensure stability. Subsequently two braces were bolted to each beam and the three elements altogether were put in place and bolted to the structure, Fig. 4.4. After the erection was completed, the bolts were tightened by a torque wrench. Bolts between column baseplates and base structure were tightened to a torque resulting in the full preload force, while all other bolts to 50% of the full preload force.

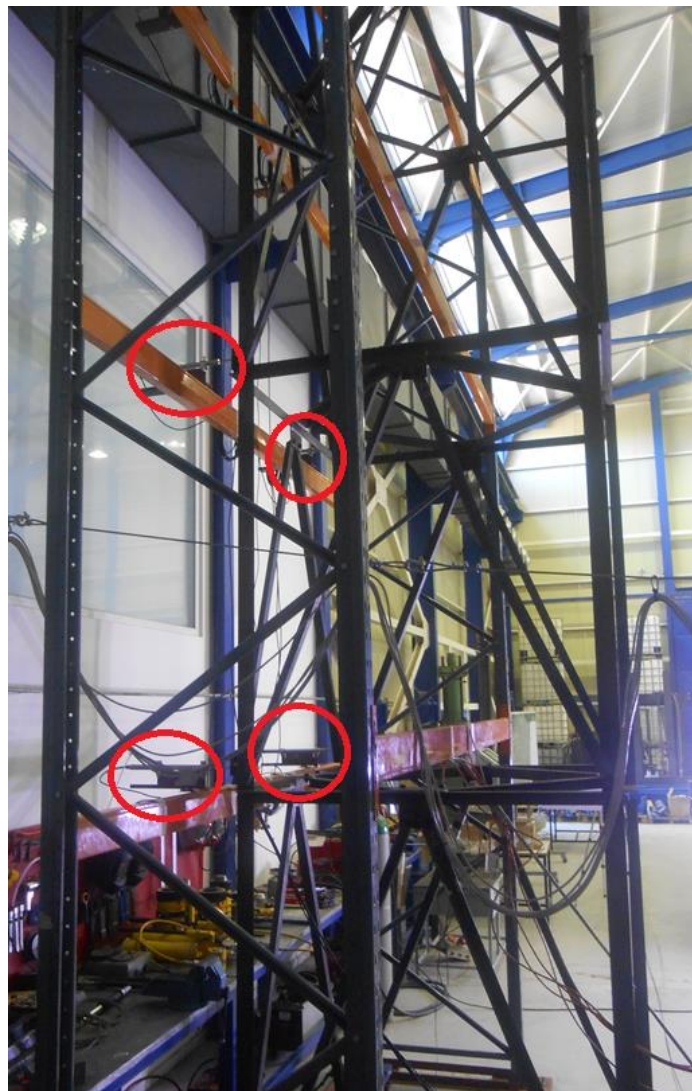
Figure 6.2: LVDTs measuring the horizontal displacements and supporting rack structure for orthogonal loading

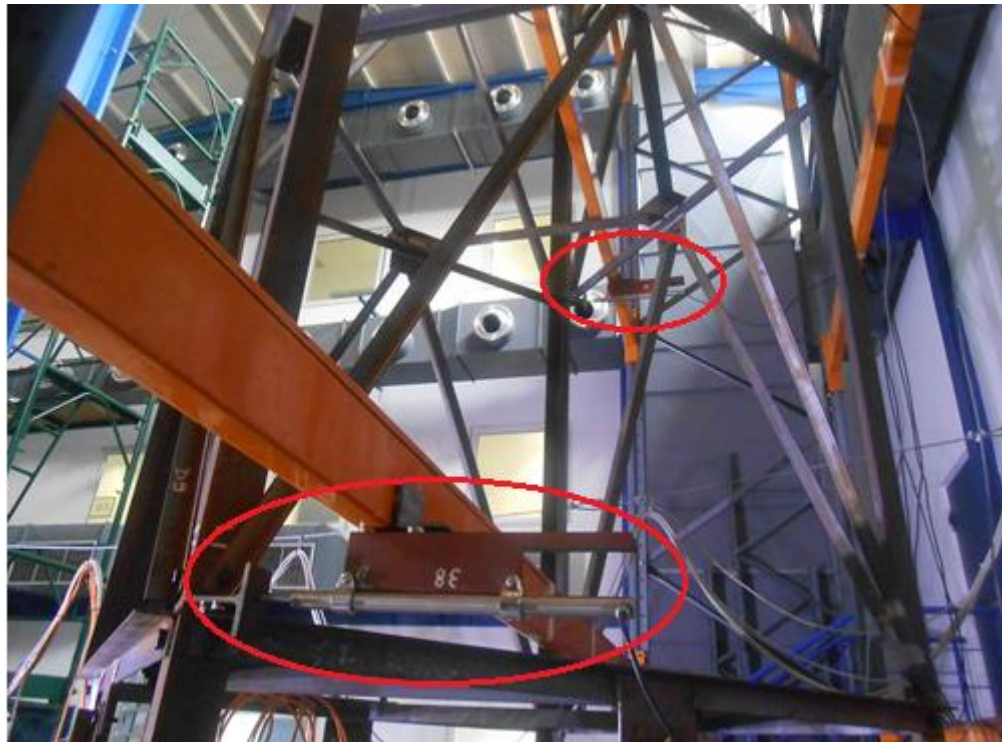
Figure 6.3: LVDTs measuring the horizontal displacements and supporting rack structure for diagonal loading

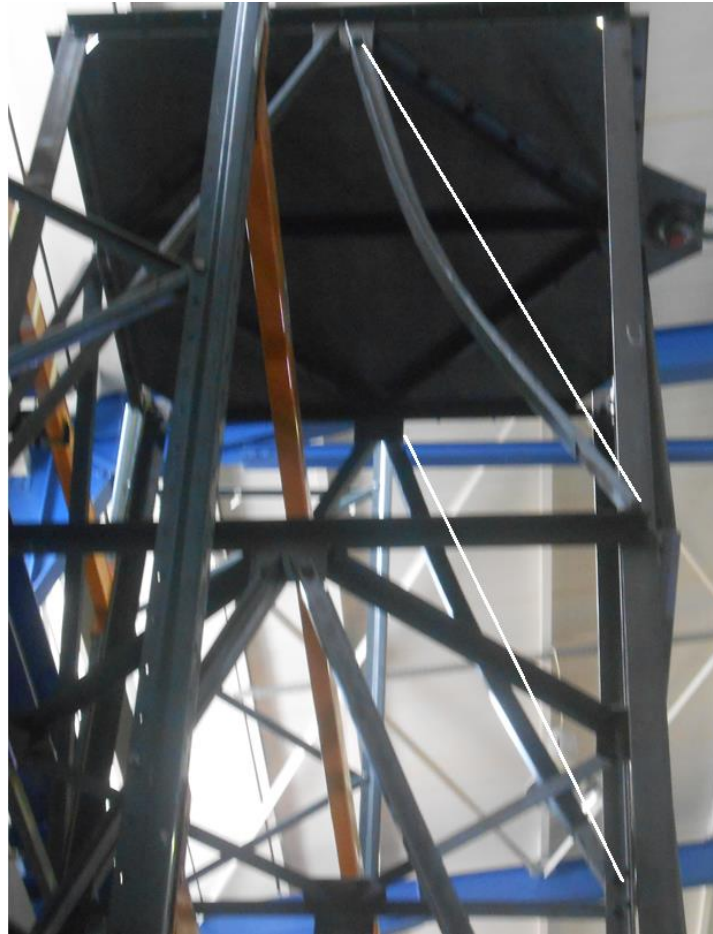
**Figure 7.19: Tower O-1S. Weak axis flexural buckling of the failed diagonals towards the lips**

Failure was due to flexural buckling of the two 4<sup>th</sup> floor compression diagonals, Fig. 7.19.

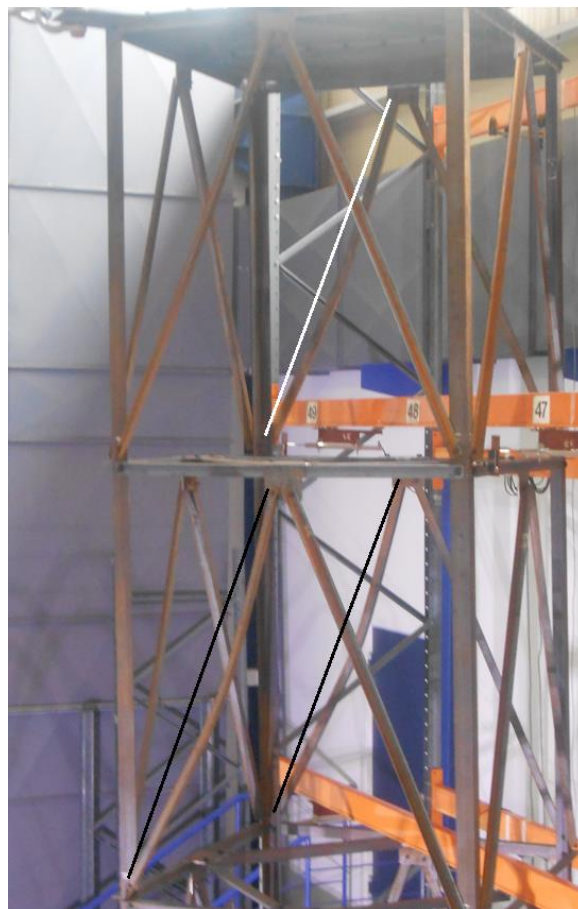
Figure 7.25: Tower D-1. Weak axis flexural buckling of the failed diagonals towards the lips

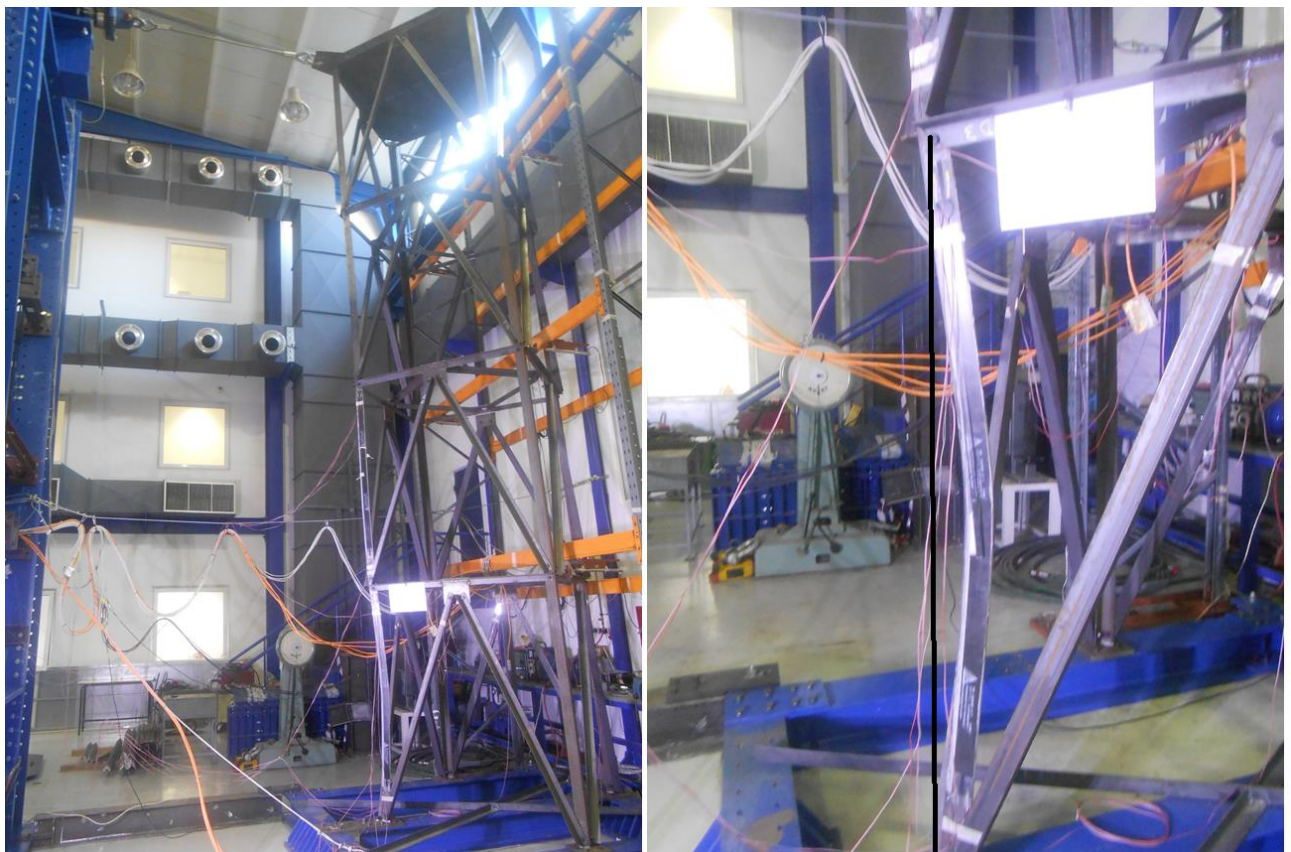
Figure 7.36: Tower D-2S. Weak axis flexural buckling of the compression leg towards the heel
