ANGELHY

**Innovative solutions for design and strengthening of
telecommunications and transmission lattice towers using large angles
from high strength steel and hybrid techniques of angles with
FRP strips**

WORK PACKAGE 3 – DELIVERABLE 3.2

Report on experimental tests on closely spaced built-up members

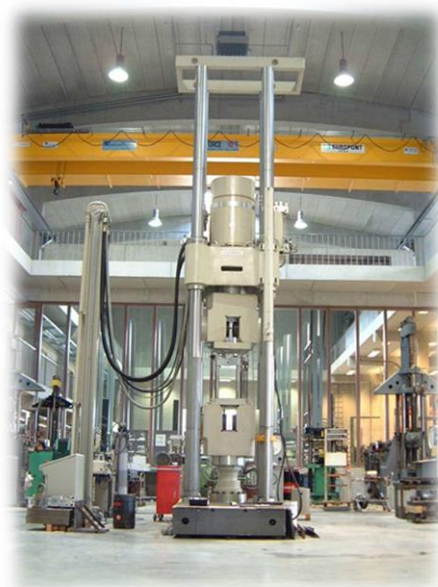
(b) General view of the test rig equipment

- Usable height between compression plates (0,5x0,5): from 0,3 to 5,2m ;
- Static force capacity of ± 2500 kN ;

The loading is done by imposed displacements.

The speed of the loading is 3mm in 10 minutes at the beginning of the test. When the load is closing the expected peak load (failure), the speed is reduced to 3mm in 20 minutes in order to avoid any potential dynamic effect.

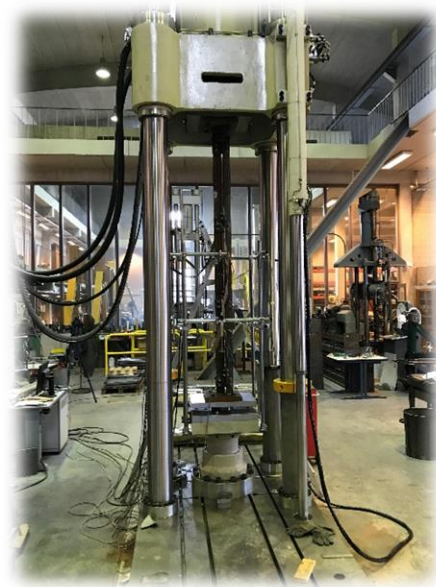
(a) SBU1 specimen test rig

Figure 3.1: General view of the test rig configuration.

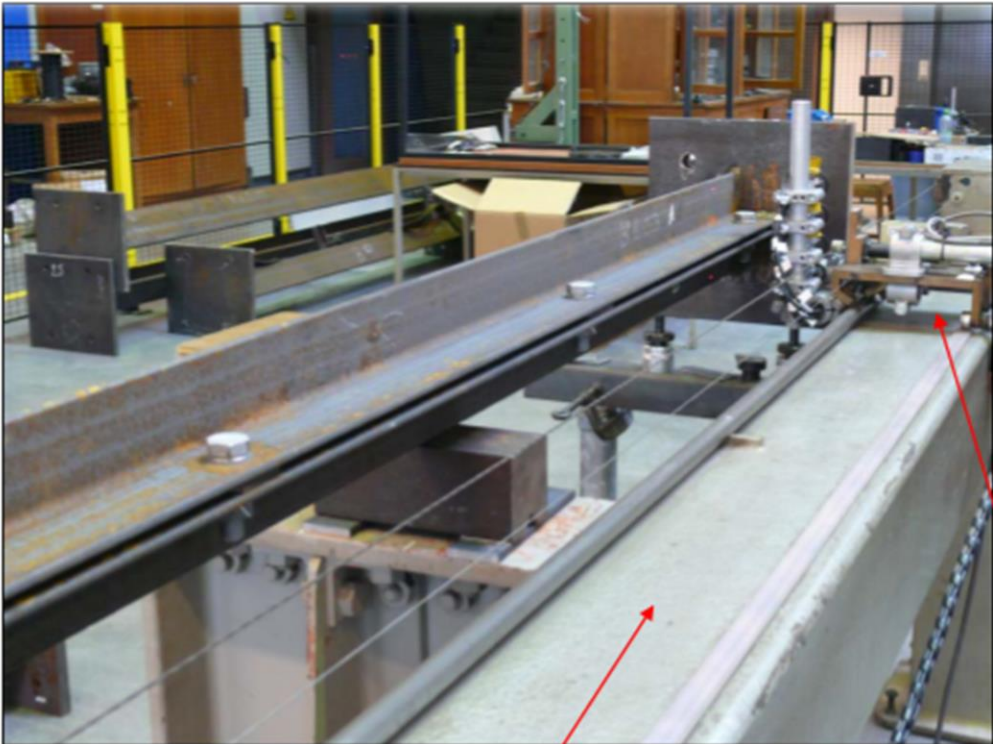
Figure 4.4: Configurations and details of the measurement system.

For each geometrical imperfection measurement, the specimen is positioned parallel to a bench equipped with a trolley carrying four laser displacement transducers. The trolley moves along the bench and each of the four laser displacement transducers measures the distance to the specimen. The same process is done with the specimen turned by 90°. This allows to have the initial deformation of the specimen in the two planes. The first measurement point is located at several centimetres from the intersection plan between the profiles and the end-plate. The laser measurement is not continuous but made by successive steps. The measurement step depends on the position of the bolts used to connect the packing plates.

Figure 4.4 and Figure 4.5 show the configurations and the details of the measurement system.

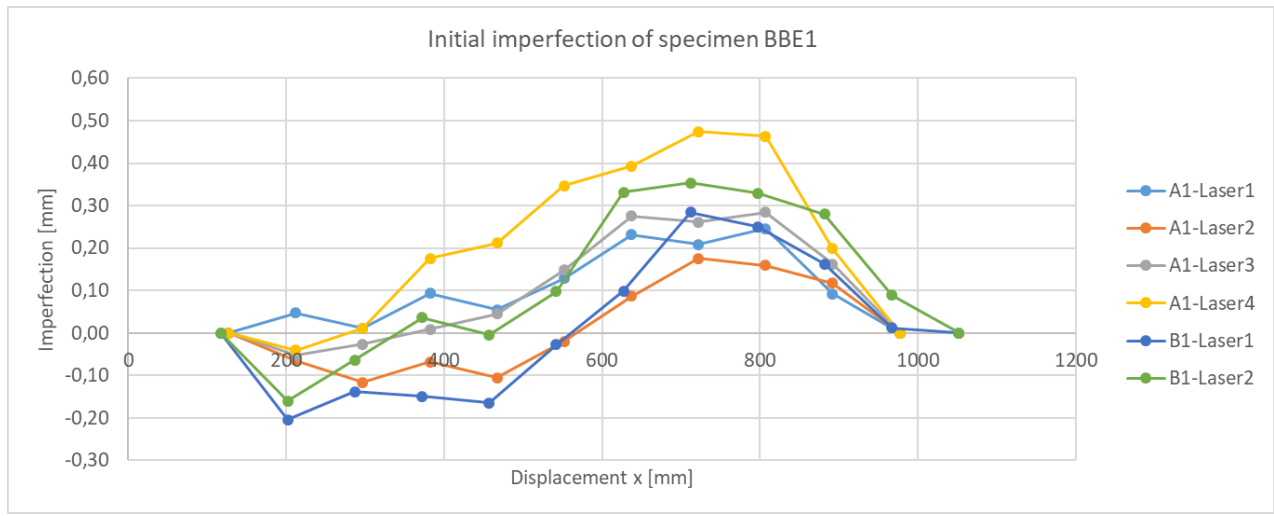
Figure 4.7: Initial imperfection of BBE1.

It is important to note that the shift of the curves is imposed by the fact that the first and last laser measurements location cannot be exactly performed at the extremities of the column (no possibility of access resulting from the presence of the welded endplates). To overpass this difficulty, it is reasonably assumed that the member is straight and without any imperfection in the small zones lying in between the column extremities and the sections where the first and last measurements are performed. The measurements of the initial imperfections are reported in graphs in Annex B for each specimen.

As explained above, the first correction brought to the raw laser measurement values concerns the non parallelism and the rotation of the metric system (the specimens and the bench axis are not perfectly parallel). The second correction consists in ensuring a zero imperfection at the extremities of the column length. The initial imperfections finally obtained for the BBE1 specimen are illustrated, as an example, in Figure 4.7.

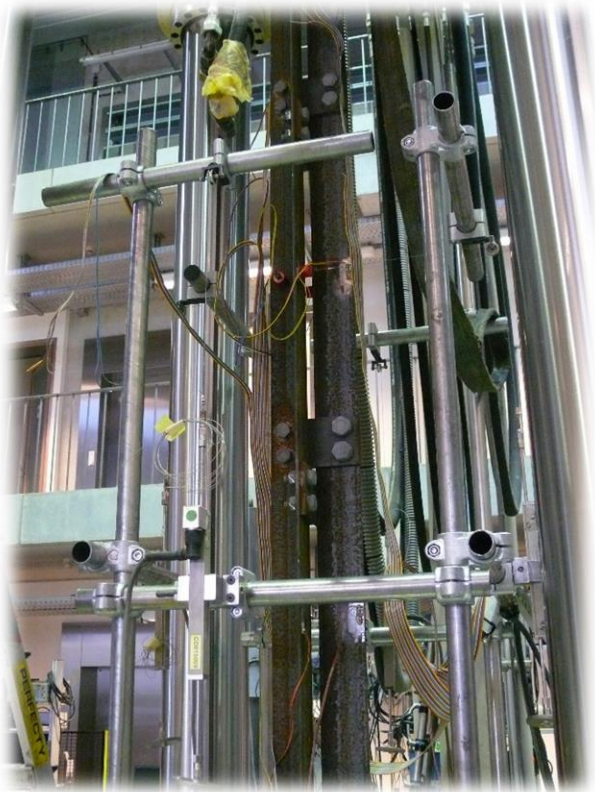
Figure 4.12: General overview of the performed measurements during the tests.

- horizontal displacements at mid-height in four cross-section locations (by means of displacements transducers) ;
- strains at 3 various heights, namely L/4, L/2 and 3L/4, in four cross-section locations (by means of strain gauges).

(b) General view of test rig with the with the measurement devices

(c) Strain gage measurement

These measurement devices are shown in Figure 4.12 below.

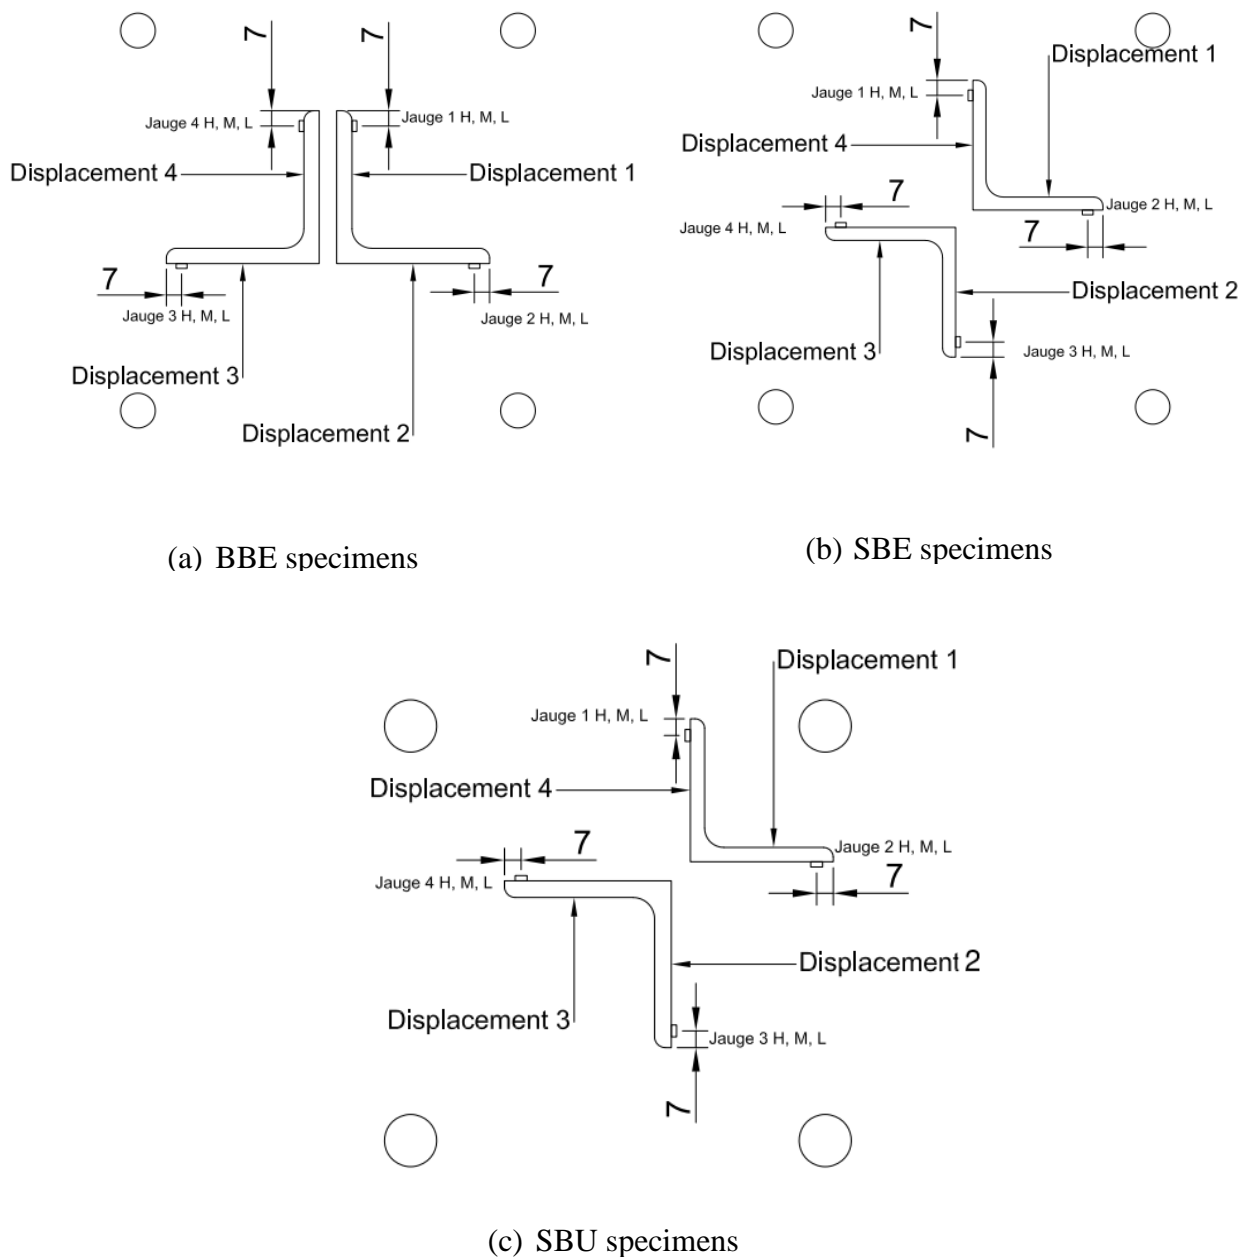
Figure 4.13: Locations of the strain gages and displacement transducers for the different types of specimen.

The displacement transducers and the strain gages are displayed differently according to the specimen category. The following Figure 4.13 indicates the location adopted for each specimen category.

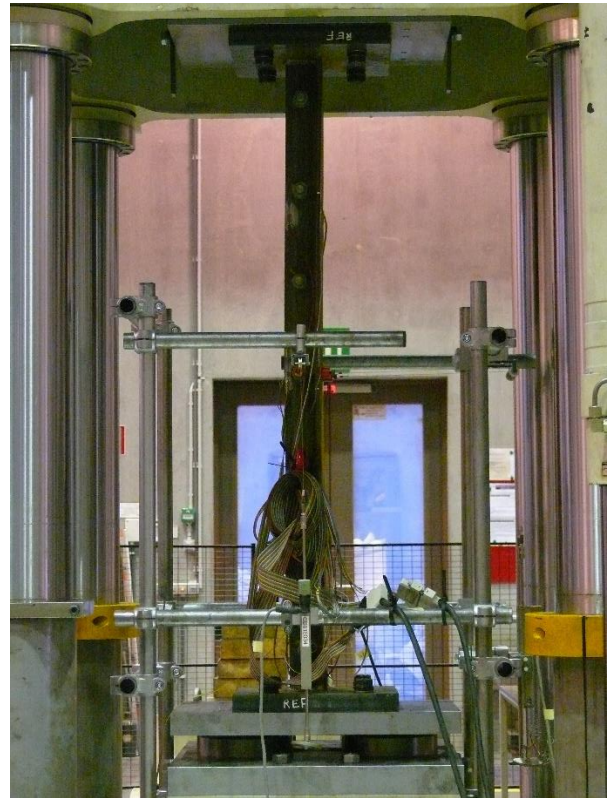
Figure B.5: Initial imperfections along specimen BBE1

ID of specimen: BBE1	
Date of testing	10/02/2020
Type of specimen	Back to back connected angles
Mean actual dimensions	
Cross-section	2 L70x70x7
ha ₂ [mm]	70,17
ea ₁ [mm]	6,77
hb ₂ [mm]	70,12
eb ₁ [mm]	6,81
a ₁ / a ₂ [mm]	86 / 75
b ₁ / b ₂ [mm]	77,6 / 66,6
a ₃ / a ₄ [mm]	85,3 / 74,3
b ₃ / b ₄ [mm]	77 / 66
L [mm]	1200
L _{crit, major-axis} [mm]	1260
L _{crit, minor-axis} [mm]	630
Tightening torque [Nm]	253
Total number of packing plates	7
Total number of bolts for packing plate connection	7 M16 10.9
Level of bolt pretension [%]	100
Material	
Actual f _y [Mpa]	414,6
Actual f _u [Mpa]	544,4
Response	
Ultimate resistance [kN]	687,56
Comments	Failure occured close to the cross-section resistance

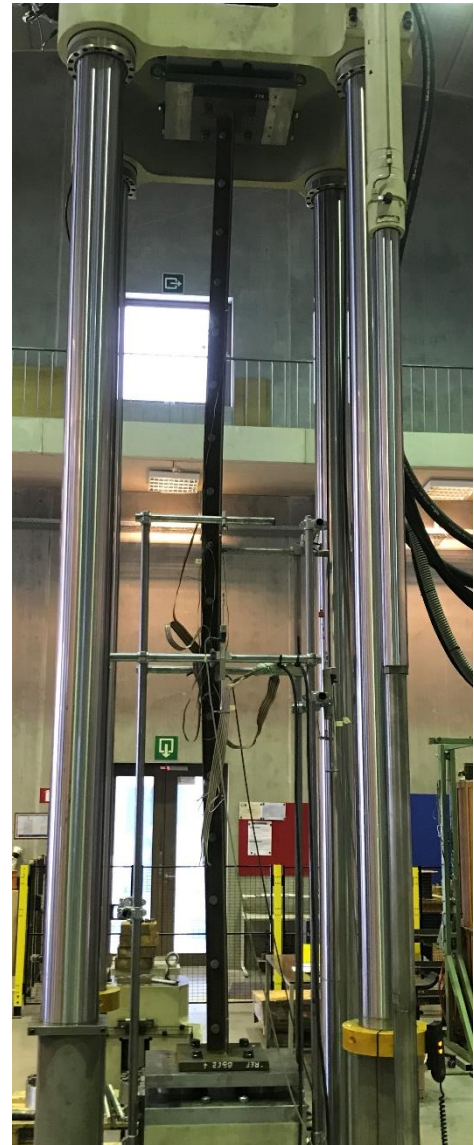
Figure B.10: Initial imperfections along specimen BBE2

ID of specimen: BBE2	
Date of testing	27/02/2020
Type of specimen	Back to back connected angles
Mean actual dimensions	
Cross-section	2 L70x70x7
ha ₂ [mm]	69,93
ea ₁ [mm]	6,86
hb ₂ [mm]	70
eb ₁ [mm]	6,83
a ₁ / a ₂ [mm]	86,3 / 75,3
b ₁ / b ₂ [mm]	77,2 / 66,2
a ₃ / a ₄ [mm]	86,4 / 75,4
b ₃ / b ₄ [mm]	77,3 / 66,3
L [mm]	3600
L _{crit, major-axis} [mm]	3660
L _{crit, minor-axis} [mm]	1830
Tightening torque [Nm]	253
Total number of packing plates	19
Total number of bolts for packing plate connection	19 M16 10.9
Level of bolt pretension [%]	100
Material	S 355
Actual f _y [Mpa]	414,6
Actual f _u [Mpa]	544,4
Response	
Ultimate resistance [kN]	485,36
Comments	Bifurcation around weak axis and no flexural buckling around strong axis as expected !

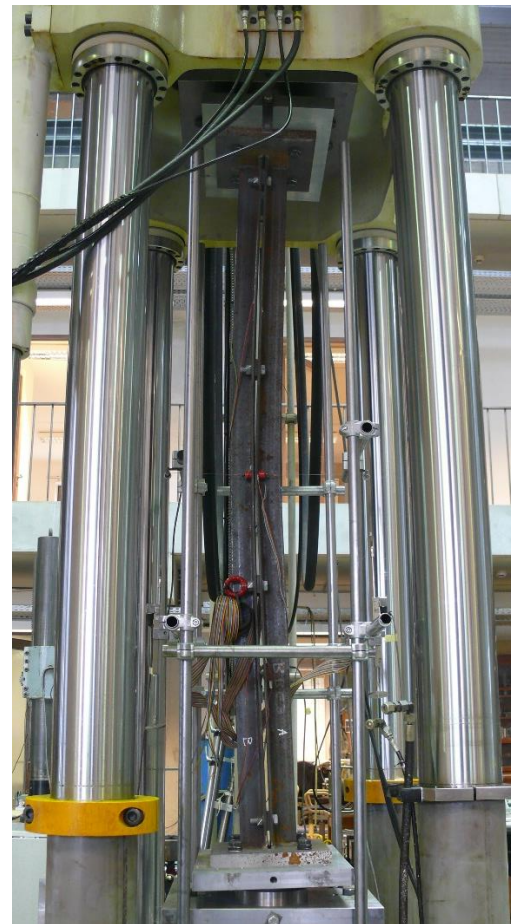
Figure B.15: Initial imperfections along specimen BBE3

ID of specimen: BBE3	
Date of testing	18/02/2020
Type of specimen	Back to back connected angles
Mean actual dimensions	
Cross-section	2 L70x70x7
ha ₂ [mm]	69,96
ea ₁ [mm]	6,82
hb ₂ [mm]	70,13
eb ₁ [mm]	6,89
a ₁ / a ₂ [mm]	87,6 / 76,6
b ₁ / b ₂ [mm]	77,7 / 66,7
a ₃ / a ₄ [mm]	82,8 / 71,8
b ₃ / b ₄ [mm]	77,4 / 66,4
L [mm]	2000
L _{crit, major-axis} [mm]	2060
L _{crit, minor-axis} [mm]	1030
Tightening torque [Nm]	253
Total number of packing plates	4
Total number of bolts for packing plate connection	4 M16 10.9
Level of bolt pretension [%]	100
Material	S 355
Actual f _y [Mpa]	414,6
Actual f _u [Mpa]	544,4
Response	
Ultimate resistance [kN]	601,61
Comments	Buckling occurred around the strong axis as expected

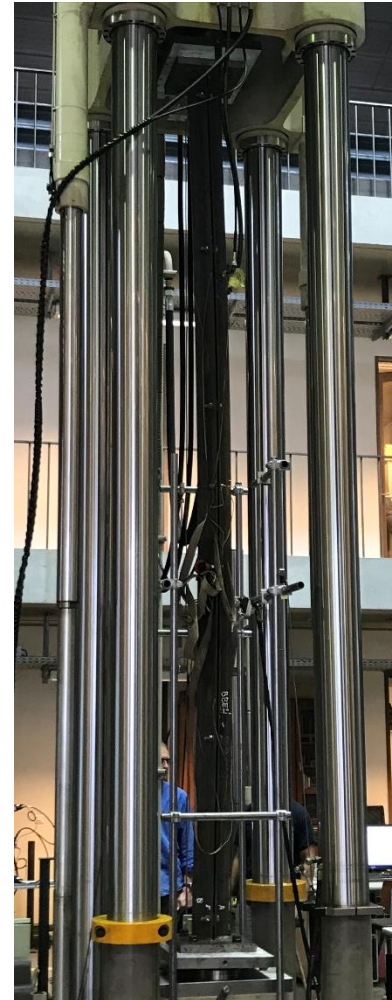
Figure B.20: Initial imperfections along specimen BBE4

ID of specimen: BBE4	
Date of testing	03/03/2020
Type of specimen	Back to back connected angles
Mean actual dimensions	
Cross-section	2 L70x70x7
ha ₂ [mm]	69,87
ea ₁ [mm]	6,82
hb ₂ [mm]	69,8
eb ₁ [mm]	6,86
a ₁ / a ₂ [mm]	89,1 / 78,1
b ₁ / b ₂ [mm]	78,4 / 67,4
a ₃ / a ₄ [mm]	87,6 / 76,6
b ₃ / b ₄ [mm]	78,5 / 67,5
L [mm]	3600
L _{crit, major-axis} [mm]	3660
L _{crit, minor-axis} [mm]	1830
Tightening torque [Nm]	253
Total number of packing plates	6
Total number of bolts for packing plate connection	6 M16 10.9
Level of bolt pretension [%]	100
Material	
Actual f _y [Mpa]	414,6
Actual f _u [Mpa]	544,4
Response	
Ultimate resistance [kN]	311,68
Comments	Buckling occurred around the strong axis as expected

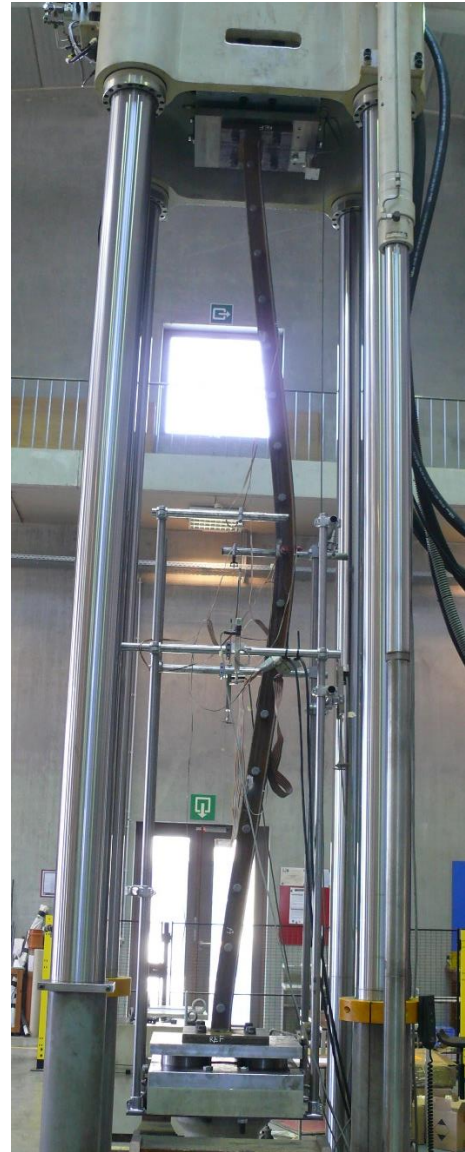
Figure B.25: Initial imperfections along specimen BBE5

ID of specimen: BBE5	
Date of testing	17/03/2020
Type of specimen	Back to back connected angles
Mean actual dimensions	
Cross-section	2 L70x70x7
ha ₂ [mm]	69,9
ea ₁ [mm]	6,83
hb ₂ [mm]	69,93
eb ₁ [mm]	6,86
a ₁ / a ₂ [mm]	87 / 76
b ₁ / b ₂ [mm]	79 / 68
a ₃ / a ₄ [mm]	86,8 / 75,8
b ₃ / b ₄ [mm]	77,5 / 66,5
L [mm]	3600
L _{crit, major-axis} [mm]	3660
L _{crit, minor-axis} [mm]	1830
Tightening torque [Nm]	25,3
Total number of packing plates	19
Total number of bolts for packing plate connection	19 M16 10.9
Level of bolt pretension [%]	10
Material	S 355
Actual f _y [Mpa]	414,6
Actual f _u [Mpa]	544,4
Response	
Ultimate resistance [kN]	423,32
Comments	Buckling around minor-axis and no flexural buckling around major-axis as expected !

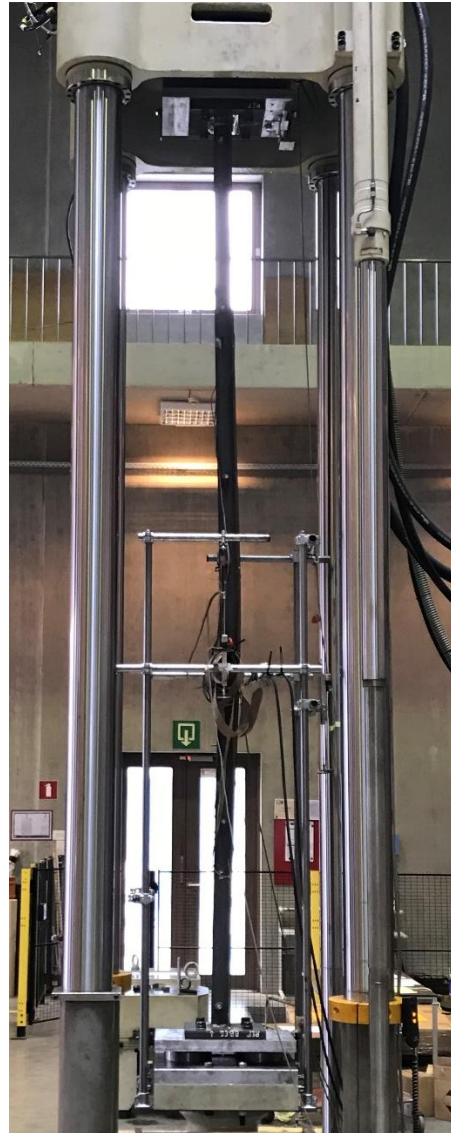
Figure B.30: Initial imperfections along specimen BBE6

ID of specimen: BBE6	
Date of testing	13/03/2020
Type of specimen	Back to back connected angles
Mean actual dimensions	
Cross-section	2 L70x70x7
ha ₂ [mm]	69,93
ea ₁ [mm]	6,84
hb ₂ [mm]	69,83
eb ₁ [mm]	6,85
a ₁ / a ₂ [mm]	87,6 / 76,6
b ₁ / b ₂ [mm]	77,6 / 66,6
a ₃ / a ₄ [mm]	89,1 / 78,1
b ₃ / b ₄ [mm]	77,9 / 66,9
L [mm]	3600
L _{crit, major-axis} [mm]	3660
L _{crit, minor-axis} [mm]	1830
Tightening torque [Nm]	25,3
Total number of packing plates	6
Total number of bolts for packing plate connection	6 M16 10.9
Level of bolt pretension [%]	10
Material	
Actual f _y [Mpa]	414,6
Actual f _u [Mpa]	544,4
Response	
Ultimate resistance [kN]	382,78
Comments	Buckling occurred around minor-axis first !

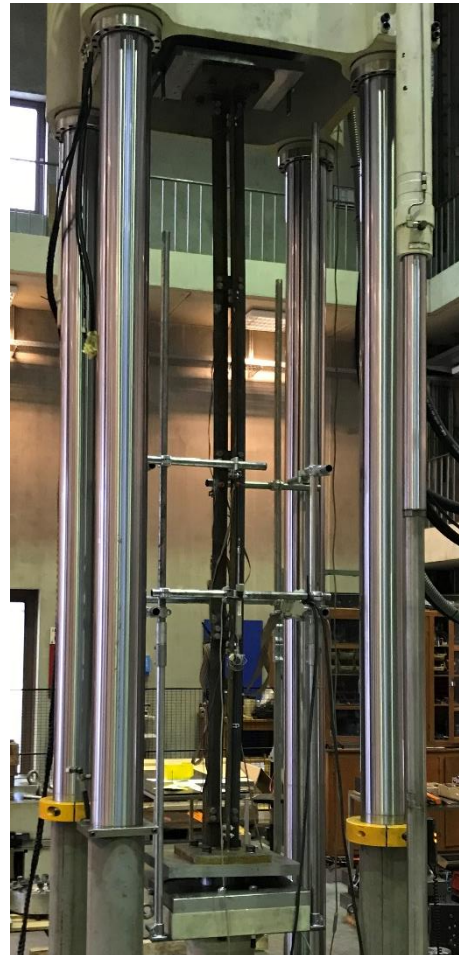
Figure B.40: Initial imperfections along specimen SBE2

ID of specimen: SBE2	
Date of testing	27/01/2020
Type of specimen	Star batteded angles with equal sections
Mean actual dimensions	
Cross-section	2 L60x60x6
ha ₁ [mm]	60,63
ea ₂ [mm]	6,05
hb ₂ [mm]	60,53
eb ₁ [mm]	6,05
a ₁ / a ₂ [mm]	102,4 / 91,4
b ₁ / b ₂ [mm]	103 / 92
a ₃ / a ₄ [mm]	100,3 / 89,3
b ₃ / b ₄ [mm]	103,8 / 92,8
L [mm]	3000
L _{crit} [mm]	3060
Tightening torque [Nm]	102
Total number of packing plates	2x5
Total number of bolts for packing plate connection	40 M12 10.9
Level of bolt pretension [%]	100
Material	S 355
Actual f _y [Mpa]	480,0
Actual f _u [Mpa]	539,9
Response	
Ultimate resistance [kN]	296,32
Comments	Instability ocured close to bifurcation

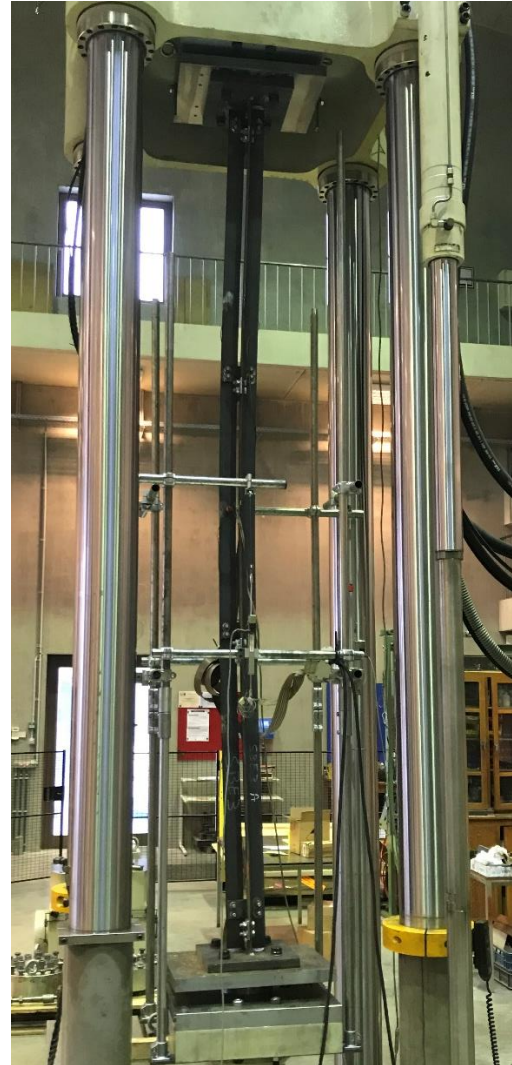
Figure B.45: Initial imperfections along specimen SBE3

ID of specimen: SBE3	
Date of testing	22/01/2020
Type of specimen	Star batteded angles with equal sections
Mean actual dimensions	
Cross-section	2 L60x60x6
ha ₁ [mm]	60,6
ea ₂ [mm]	6,02
hb ₂ [mm]	59,8
eb ₁ [mm]	5,85
a ₁ / a ₂ [mm]	101,6 / 90,6
b ₁ / b ₂ [mm]	102 / 91
a ₃ / a ₄ [mm]	104,1 / 93,1
b ₃ / b ₄ [mm]	102,1 / 91,1
L [mm]	3000
L _{crit} [mm]	3060
Tightening torque [Nm]	102
Total number of packing plates	2x4
Total number of bolts for packing plate connection	32 M12 10.9
Level of bolt pretension [%]	100
Material	S 355
Actual f _y [Mpa]	480,0
Actual f _u [Mpa]	539,9
Response	
Ultimate resistance [kN]	283,10
Comments	Instability occured close to bifurcation

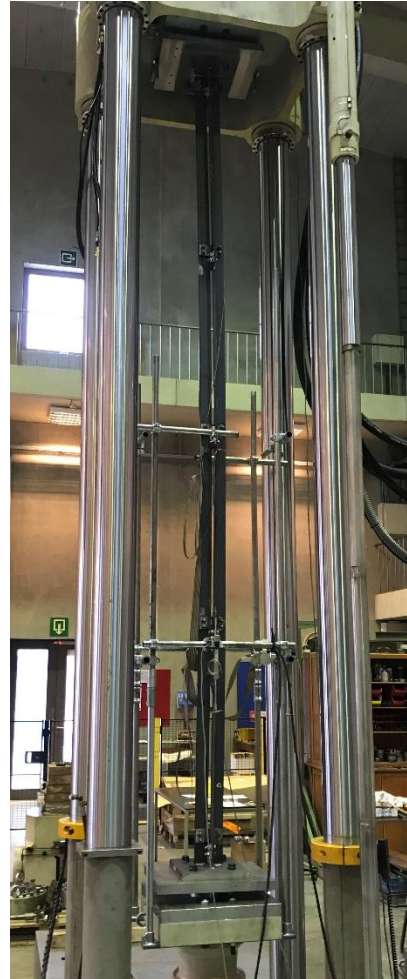
Figure B.50: Initial imperfections along specimen SBE4

ID of specimen: SBE4	
Date of testing	03/02/2020
Type of specimen	Star batteded angles with equal sections
Mean actual dimensions	
Cross-section	2 L60x60x6
ha ₁ [mm]	60,53
ea ₂ [mm]	5,92
hb ₂ [mm]	60,57
eb ₁ [mm]	6,1
a ₁ / a ₂ [mm]	104,1 / 93,1
b ₁ / b ₂ [mm]	101,7 / 90,7
a ₃ / a ₄ [mm]	101 / 90
b ₃ / b ₄ [mm]	103,2 / 92,2
L [mm]	4000
L _{crit} [mm]	4060
Tightening torque [Nm]	102
Total number of packing plates	2x5
Total number of bolts for packing plate connection	40 M12 10.9
Level of bolt pretension [%]	100
Material	S 355
Actual f _y [Mpa]	480,0
Actual f _u [Mpa]	539,9
Response	
Ultimate resistance [kN]	127,41
Comments	/

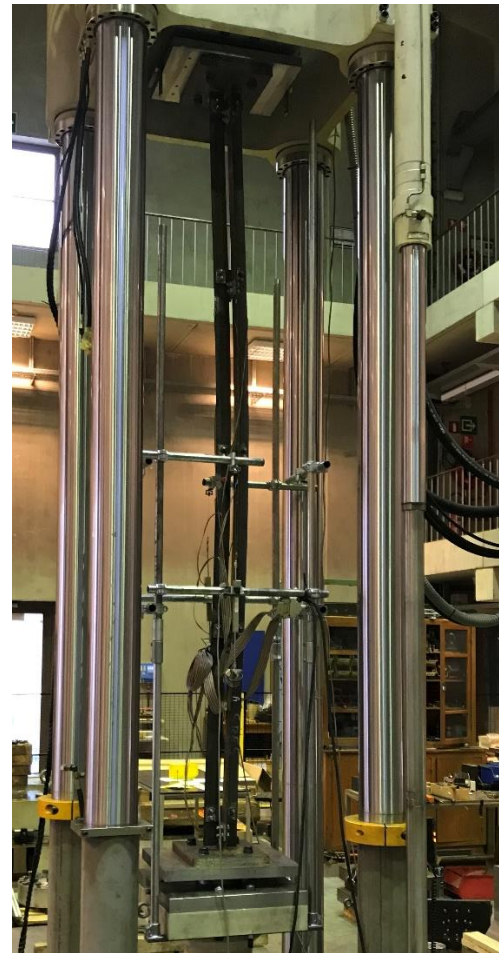
Figure B.55: Initial imperfections along specimen SBE5

ID of specimen: SBE5	
Date of testing	27/01/2020
Type of specimen	Star batteded angles with equal sections
Mean actual dimensions	
Cross-section	2 L60x60x6
ha ₁ [mm]	60,53
ea ₂ [mm]	6,05
hb ₂ [mm]	60,87
eb ₁ [mm]	5,91
a ₁ / a ₂ [mm]	101,3 / 90,3
b ₁ / b ₂ [mm]	103,7 / 92,7
a ₃ / a ₄ [mm]	103,2 / 92,2
b ₃ / b ₄ [mm]	103,6 / 92,6
L [mm]	3000
L _{crit} [mm]	3060
Tightening torque [Nm]	10,2
Total number of packing plates	2x5
Total number of bolts for packing plate connection	40 M12 10.9
Level of bolt pretension [%]	10
Material	S 355
Actual f _y [Mpa]	480,0
Actual f _u [Mpa]	539,9
Response	
Ultimate resistance [kN]	251,92
Comments	Instability ocured close to bifurcation

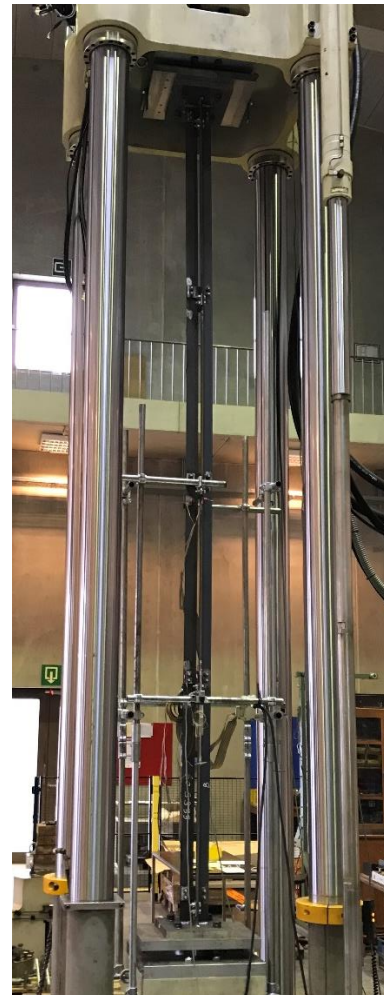
Figure B.60: Initial imperfections along specimen SBE6

ID of specimen: SBE6	
Date of testing	30/01/2020
Type of specimen	Star batteded angles with equal sections
Mean actual dimensions	
Cross-section	2 L60x60x6
ha ₁ [mm]	59,87
ea ₂ [mm]	6,1
hb ₂ [mm]	60,57
eb ₁ [mm]	6,07
a ₁ / a ₂ [mm]	102,6 / 91,6
b ₁ / b ₂ [mm]	102,8 / 91,8
a ₃ / a ₄ [mm]	100,5 / 89,5
b ₃ / b ₄ [mm]	102,3 / 91,3
L [mm]	4000
L _{crit} [mm]	4060
Tightening torque [Nm]	10,2
Total number of packing plates	2x5
Total number of bolts for packing plate connection	40 M12 10.9
Level of bolt pretension [%]	10
Material	S 355
Actual f _y [Mpa]	480,0
Actual f _u [Mpa]	539,9
Response	
Ultimate resistance [kN]	81,47
Comments	Peak load close to the predicted one

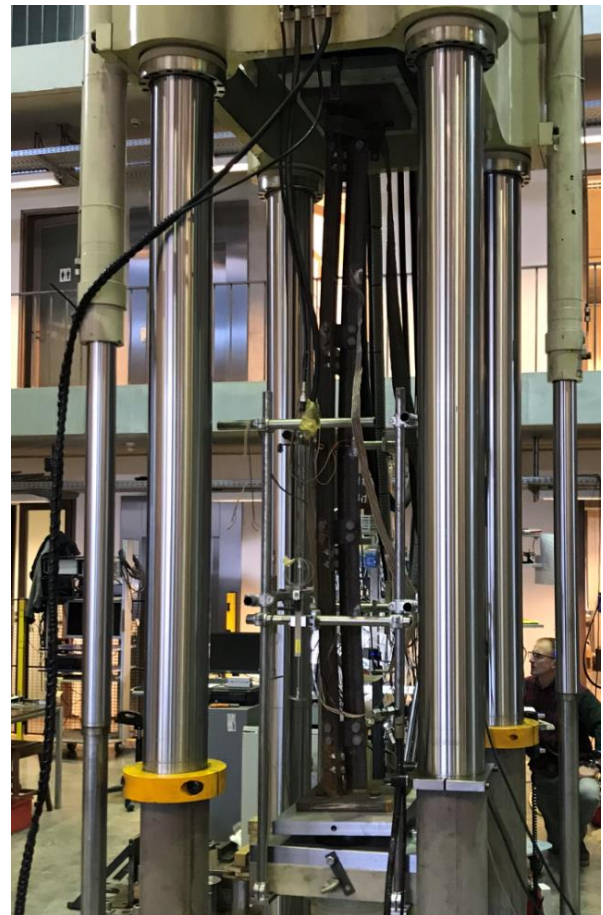
Figure B.65: Initial imperfections along specimen SBU1

ID of specimen: SBU1	
Date of testing	07/01/2020
Type of specimen	Star batteded angles with unequal sections
Mean actual dimensions	
Cross-section	L70x70x7 + L60x60x6
ha ₁ [mm]	69,87
ea ₁ [mm]	6,93
hb ₂ [mm]	59,87
eb ₁ [mm]	6,03
a ₁ / a ₂ [mm]	75,1 / 64,1
b ₁ / b ₂ [mm]	77 / 66
a ₃ / a ₄ [mm]	75,5 / 64,5
b ₃ / b ₄ [mm]	75,5 / 64,5
L [mm]	2200
L _{crit} [mm]	2260
Tightening torque [Nm]	253/102
Total number of packing plates	2x4
Total number of bolts for packing plate connection	16 M16 10.9 16 M12 10.9
Level of bolt pretension [%]	100
Material	S 355
Actual f _y [Mpa]	414,6 / 480,0
Actual f _u [Mpa]	544,4 / 539,9
Response	
Ultimate resistance [kN]	231,97
Comments	Classical flexural buckling occured close to the predicted load. One slip occured during the test.

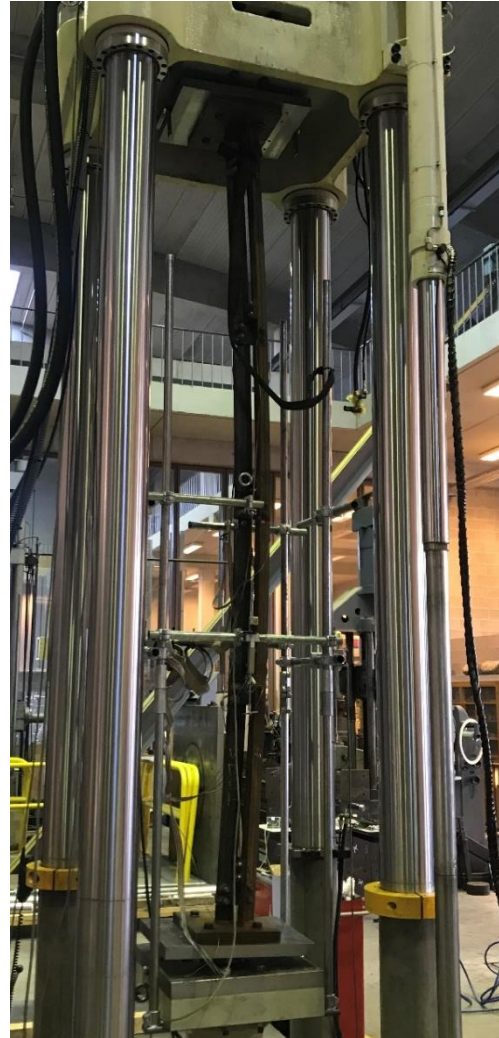
Figure B.70: Initial imperfections along specimen SBU2

ID of specimen: SBU2	
Date of testing	16/01/2020
Type of specimen	Star batteded angles with unequal sections
Mean actual dimensions	
Cross-section	L70x70x7 + L60x60x6
ha ₁ [mm]	69,93
ea ₁ [mm]	6,89
hb ₂ [mm]	60,13
eb ₁ [mm]	6,07
a ₁ / a ₂ [mm]	75,8 / 64,8
b ₁ / b ₂ [mm]	73,6 / 62,6
a ₃ / a ₄ [mm]	73,9 / 62,9
b ₃ / b ₄ [mm]	73,5 / 62,5
L [mm]	3000
L _{crit} [mm]	3060
Tightening torque [Nm]	253/102
Total number of packing plates	2x5
Total number of bolts for packing plate connection	20 M16 10.9 20 M12 10.9
Level of bolt pretension [%]	100
Material	S 355
Actual f _y [Mpa]	414,6 / 480,0
Actual f _u [Mpa]	544,4 / 539,9
Response	
Ultimate resistance [kN]	168,26
Comments	Classical flexural buckling occured close to the predicted load

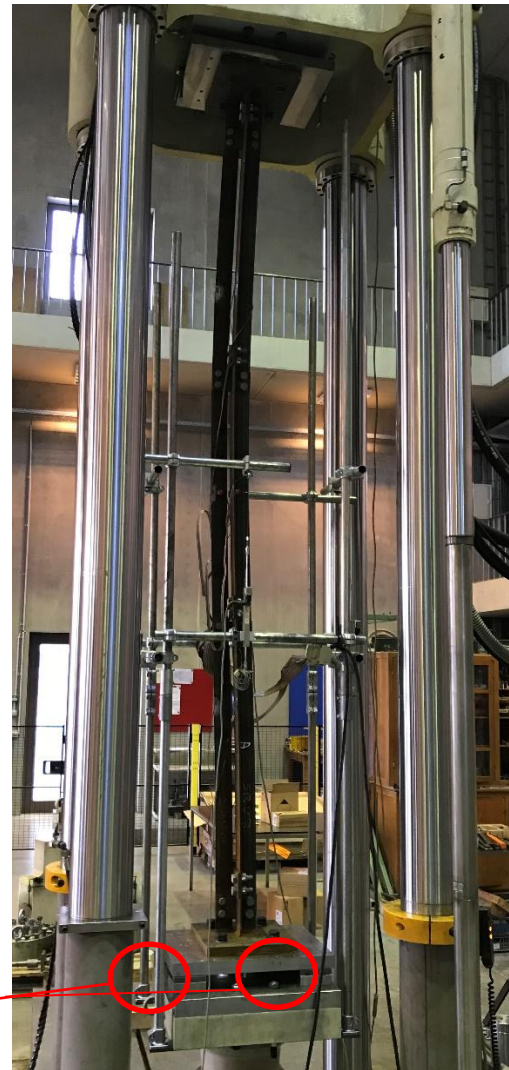
Figure B.75: Initial imperfections along specimen SBU3

ID of specimen: SBU3	
Date of testing	21/01/2020
Type of specimen	Star batteded angles with unequal sections
Mean actual dimensions	
Cross-section	L70x70x7 + L60x60x6
ha ₁ [mm]	69,9
ea ₁ [mm]	6,91
hb ₂ [mm]	60,37
eb ₁ [mm]	6,01
a ₁ / a ₂ [mm]	74,4 / 63,4
b ₁ / b ₂ [mm]	79,2 / 68,2
a ₃ / a ₄ [mm]	77,1 / 66,1
b ₃ / b ₄ [mm]	75,8 / 64,8
L [mm]	3000
L _{crit} [mm]	3060
Tightening torque [Nm]	25,3/10,2
Total number of packing plates	2x4
Total number of bolts for packing plate connection	16 M16 10.9 16 M12 10.9
Level of bolt pretension [%]	10
Material	S 355
Actual f _y [Mpa]	414,6 / 480,0
Actual f _u [Mpa]	544,4 / 539,9
Response	
Ultimate resistance [kN]	152,54
Comments	Classical flexural buckling occurred but with wrong support conditions Be careful : Rotation fixed at bottom hinge

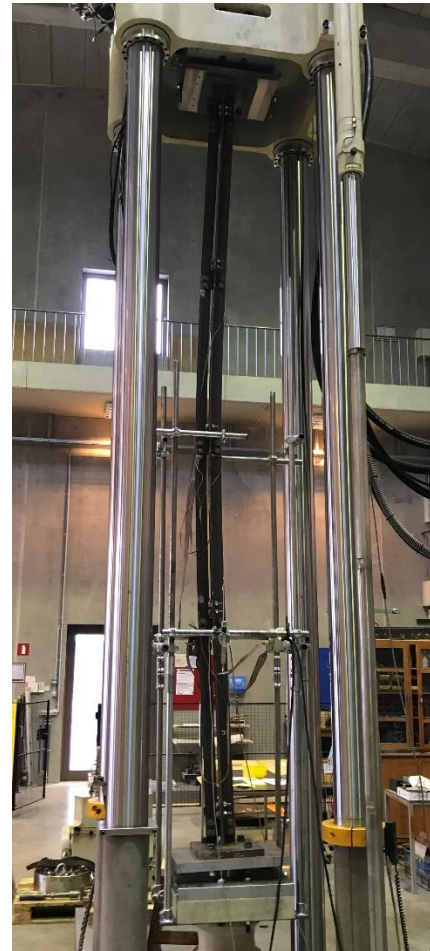
Figure B.80: Initial imperfections along specimen SBU4

ID of specimen: SBU4	
Date of testing	04/02/2020
Type of specimen	Star batted angles with unequal sections
Mean actual dimensions	
Cross-section	L70x70x7 + L60x60x6
ha ₁ [mm]	69,93
ea ₁ [mm]	6,89
hb ₂ [mm]	59,62
eb ₁ [mm]	5,88
a ₁ / a ₂ [mm]	76,5 / 65,5
b ₁ / b ₂ [mm]	73,8 / 62,8
a ₃ / a ₄ [mm]	75,7 / 64,7
b ₃ / b ₄ [mm]	76,3 / 65,3
L [mm]	4000
L _{crit} [mm]	4060
Tightening torque [Nm]	25,3/10,2
Total number of packing plates	2x5
Total number of bolts for packing plate connection	20 M16 10.9 20 M12 10.9
Level of bolt pretension [%]	10
Material	S 355
Actual f _y [Mpa]	414,6 / 480,0
Actual f _u [Mpa]	544,4 / 539,9
Response	
Ultimate resistance [kN]	84,68
Comments	Classical flexural buckling occurred
